Manhole Inspection Summary

Manhole # **S11KK1010MH**

Insp Date: **5/31/07 10:44 AM**

Location Address: **4601 HOMER AVE**

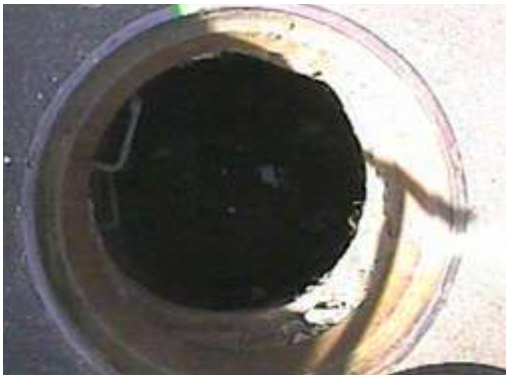
Defect 1

Offset: **3** (in.)

FRAME OFFSET

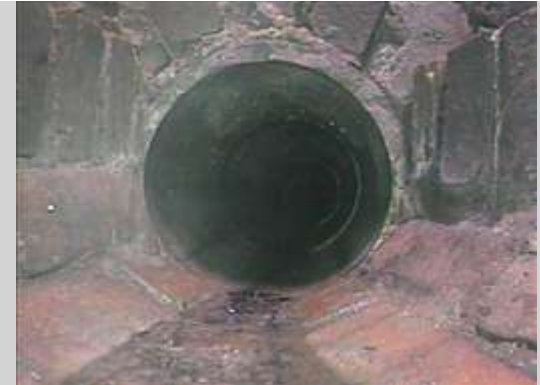
12 O'Clock Outflow

8 in. Circular Gravity Sewer
Pipe Out @ 12 O'Clock

Pipe Height: (in.) Direct
Pipe Material: **Clay** ☐ Pipe Lined
Invert Depth: **8.44** (ft.) Flow Characteristics: **Slow**
Deposits: ☒ None ☐ Mud ☐ Sludge ☐ Debris ☐ Grease
Silt Depth: (in.) Deposits Extent:
Infiltration: **None** Pipe Seal Cond: **Cracked**

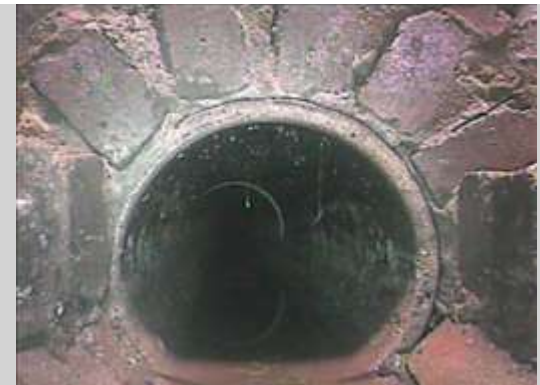
3 O'Clock Inflow

8 in. Circular Gravity Sewer
Pipe In @ 3 O'Clock

Pipe Height: (in.) Direct
Pipe Material: **Clay** ☐ Pipe Lined
Invert Depth: **8.34** (ft.) Flow Characteristics: **Slow**
Deposits: ☒ None ☐ Mud ☐ Sludge ☐ Debris ☐ Grease
Silt Depth: (in.) Deposits Extent:
Infiltration: **None** Pipe Seal Cond: **Cracked**

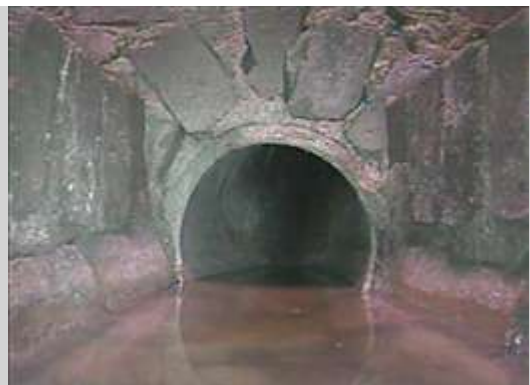
6 O'Clock Inflow

6 in. Circular Gravity Sewer
Pipe In @ 6 O'Clock

Pipe Seal Cond: **Sound**
